Manhole Inspection Summary

Manhole # S35YY_014MH

Location Address: **101 33RD ST**

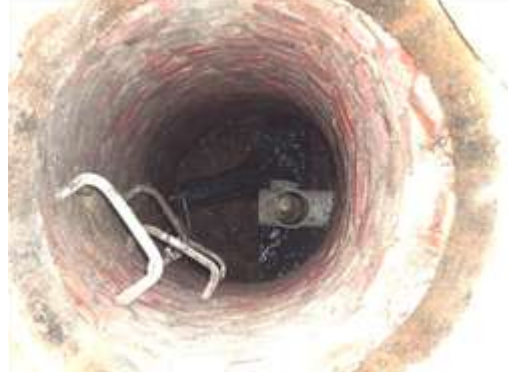
Top View

Bench debris.

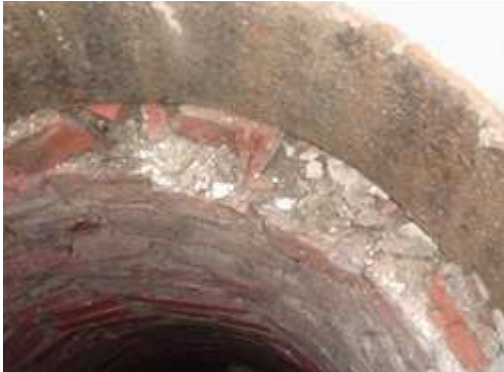
Defect

Frame Offset: **4** (in.) Condition: ☐ Sound ☐ Cracked ☒ **Leaks**

Condition: ☐ Sound ☐ Cracked ☐ Root Intrusion ☒ **Loose Brick** ☒ **Deteriorated**

Infiltration: ☐ None ☒ **Joint** ☐ Cracks ☐ Mortar ☐ Roots ☒ **Wall**

Frame leaks. Frame offset. Adjustment deterioration, loose brick and infiltration.

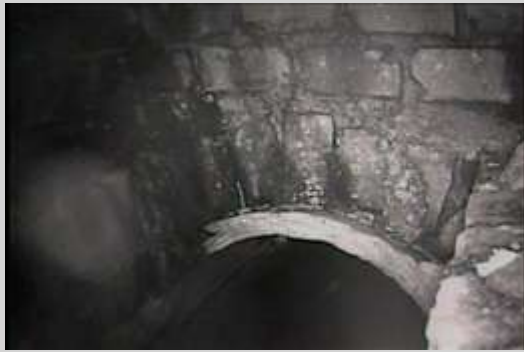
18 in. Circular Gravity Sewer

Infiltration: **Evidence** Pipe Seal Cond: **Unknown**

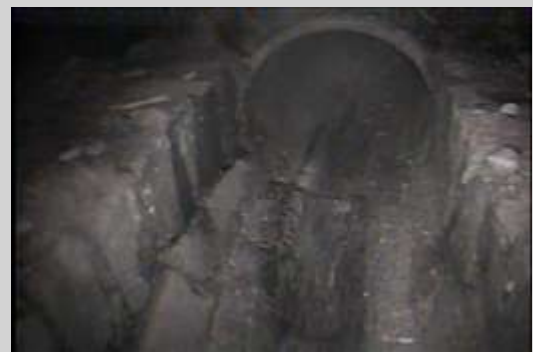
Drop In @ 9 O'Clock

Channel deterioration.
